Central U.S. Earthquakes: History & What to Expect

> Robert A. Bauer Illinois State Geological Survey

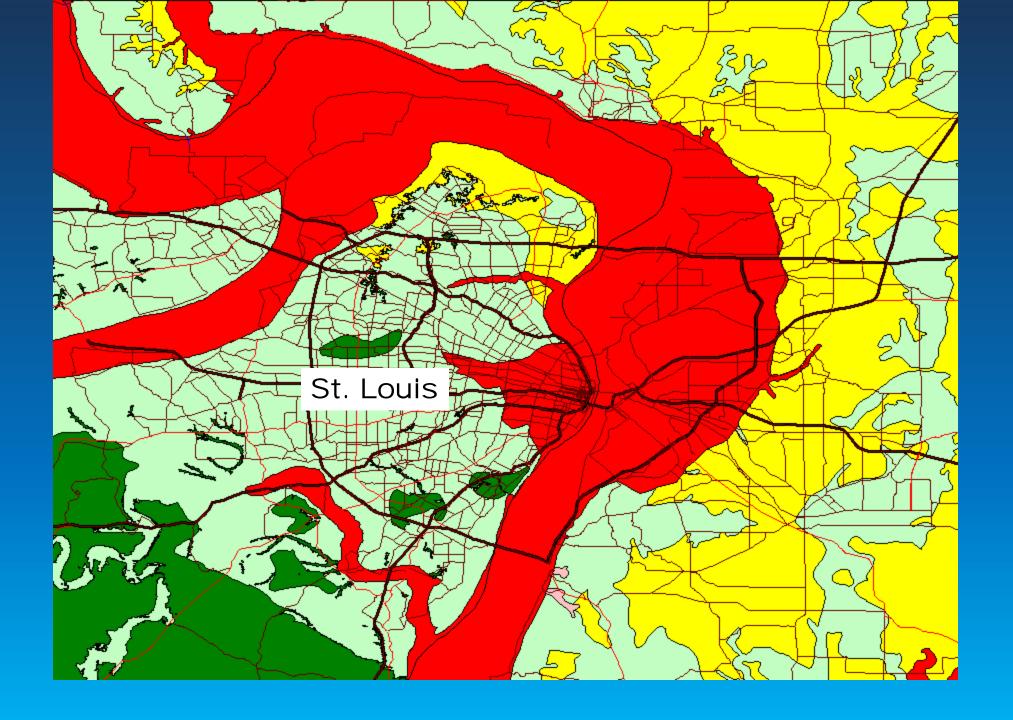
Thick, soft, wet river sediments amplify earthquake ground motions compared to bedrock.

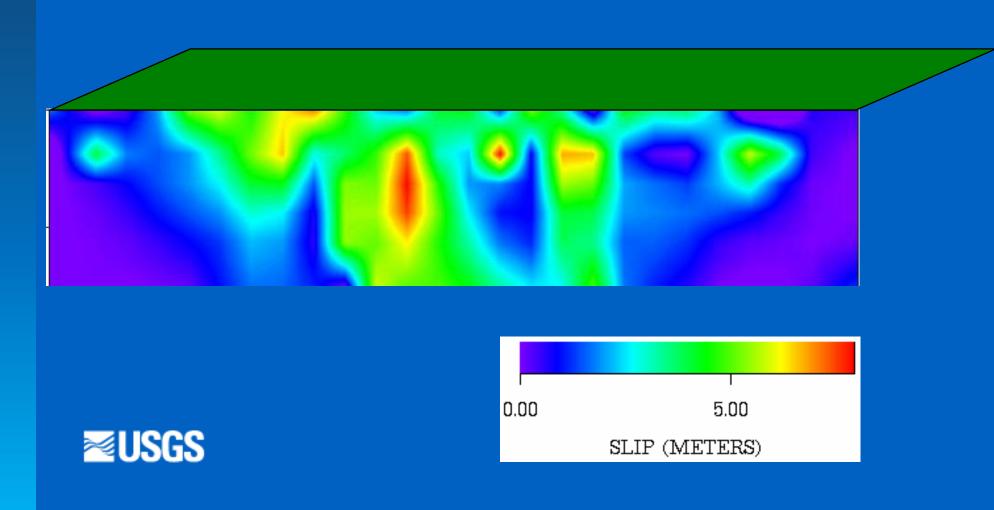
Rupture on Fault for M7.3 Landers Earthquake

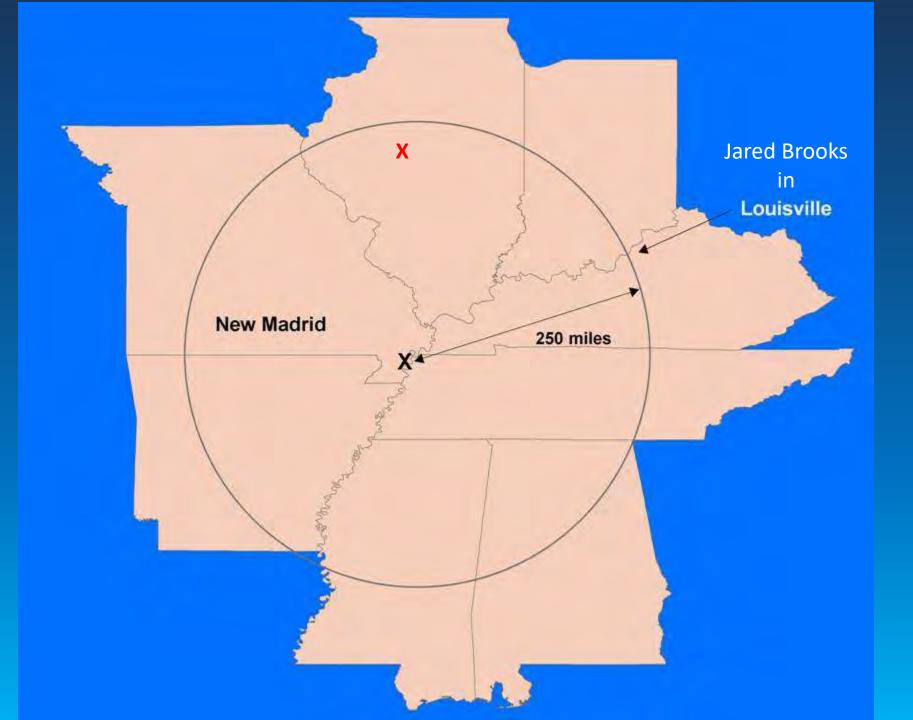
Dec. 16, 1811 Mw ≈ 7.6

2:15 am. commencing with about half the strength to which it gradually increased in about one minute; held at tremendous about one minute, then gradually subsided; whole duration, from $3\frac{1}{2}$ to 4 minutes; other slight motions follow. 2:35 am - Moderate motion 15 seconds.

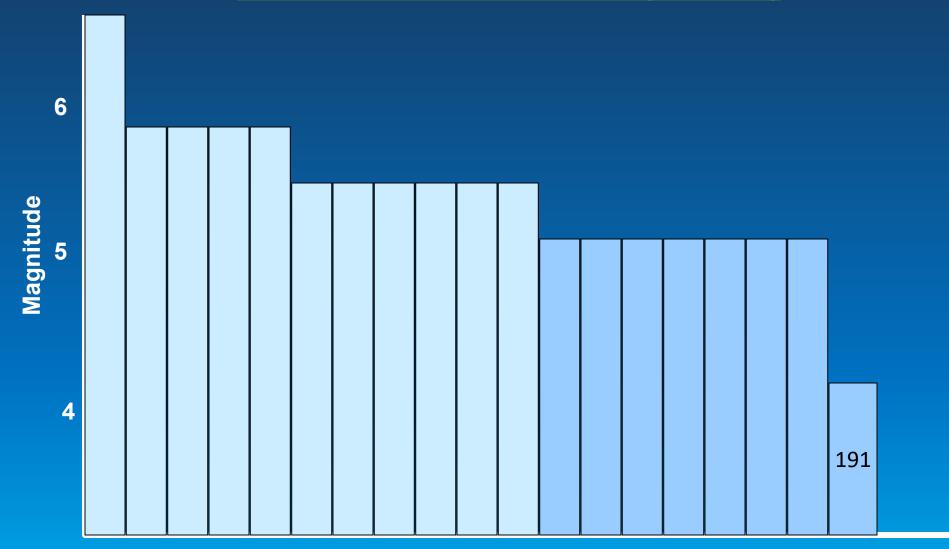
Aftershocks Second Week after Second New Madrid Fault Rupture (209 eqs)

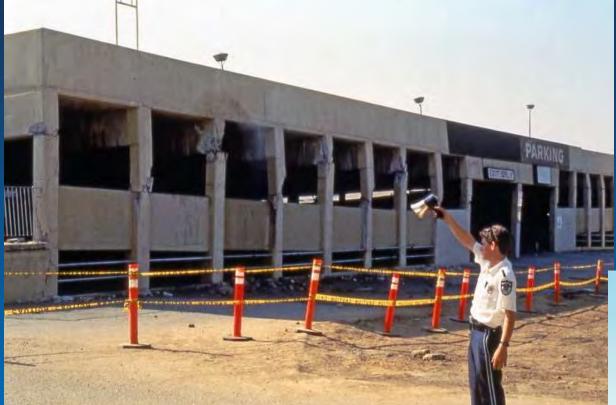
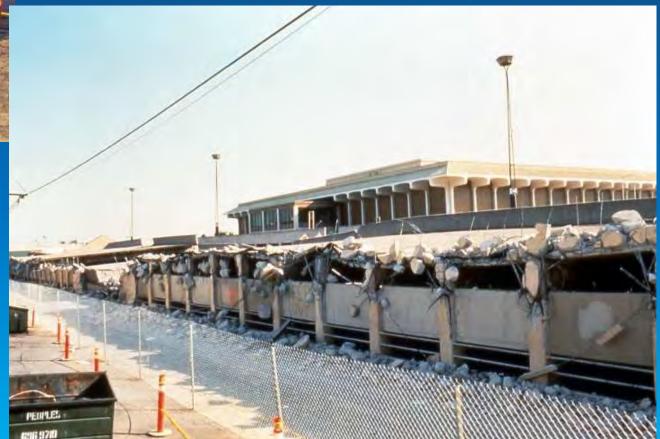
Main shock damage

Additional damage with aftershock

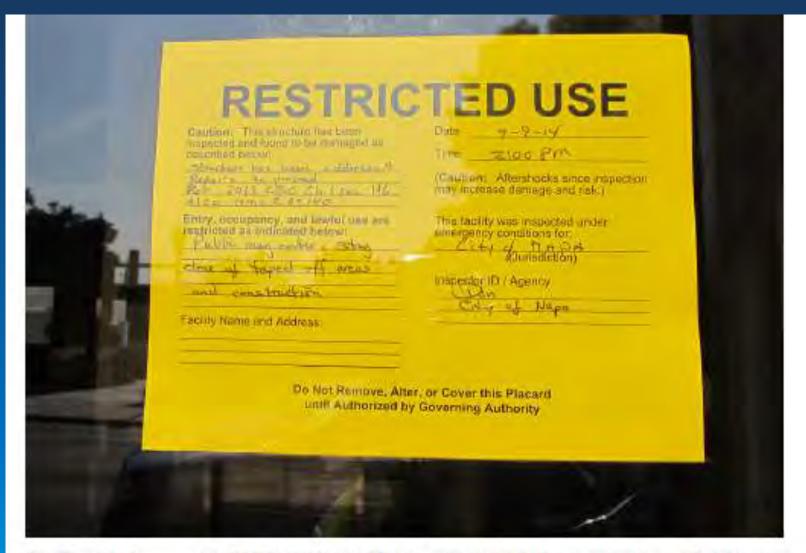
Figure 11-2 A RESTRICTED USE tag with restrictions noted as "Public may enter. Stay clear of taped off areas and construction."

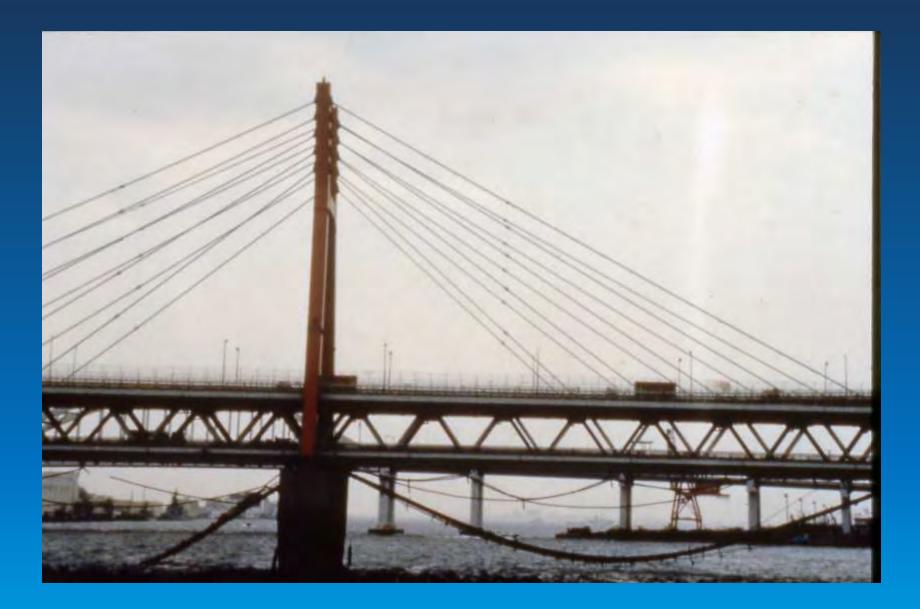
Bridge is fine – utilities are damaged – Kobe, Japan

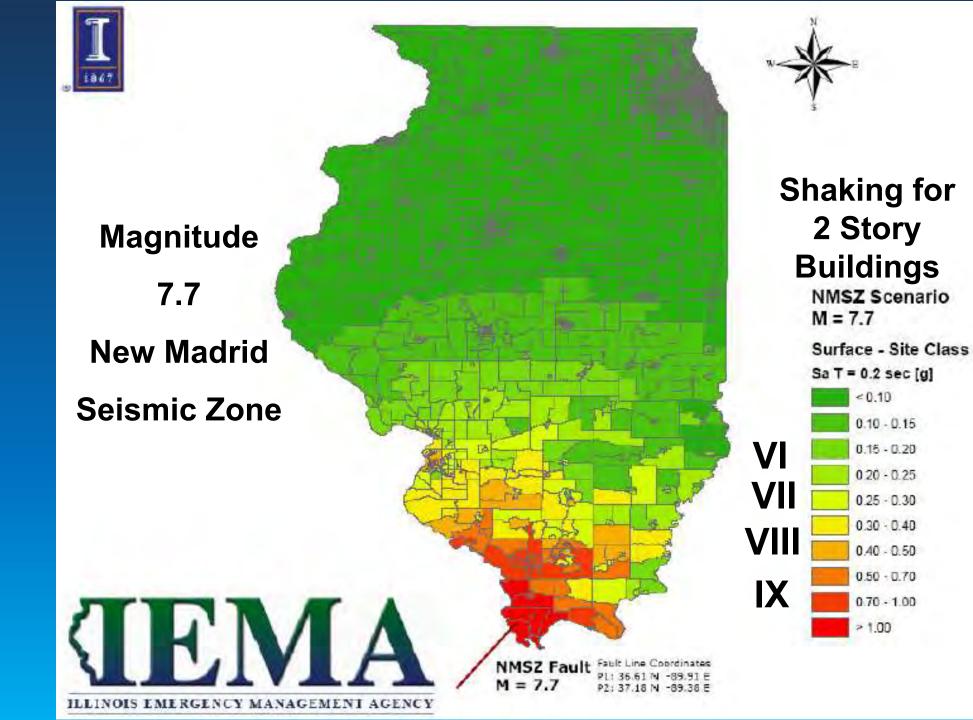
Mag. 7.7 on New Madrid

Estimated Damage in Illinois

<u>Slight damage</u> = 67,000 structures - small cracks in masonry chimneys and masonry veneer

<u>Moderate</u> = 41,000 - large cracks in chimneys toppling of tall masonry chimneys

<u>Extensive</u> = 10,000 - toppling of most brick chimneys, permanent lateral movement of floors & roof, cracks in foundations, partial collapse of soft story floors.

<u>Complete</u> = 20,000 - may collapse or be in imminent danger of collapse

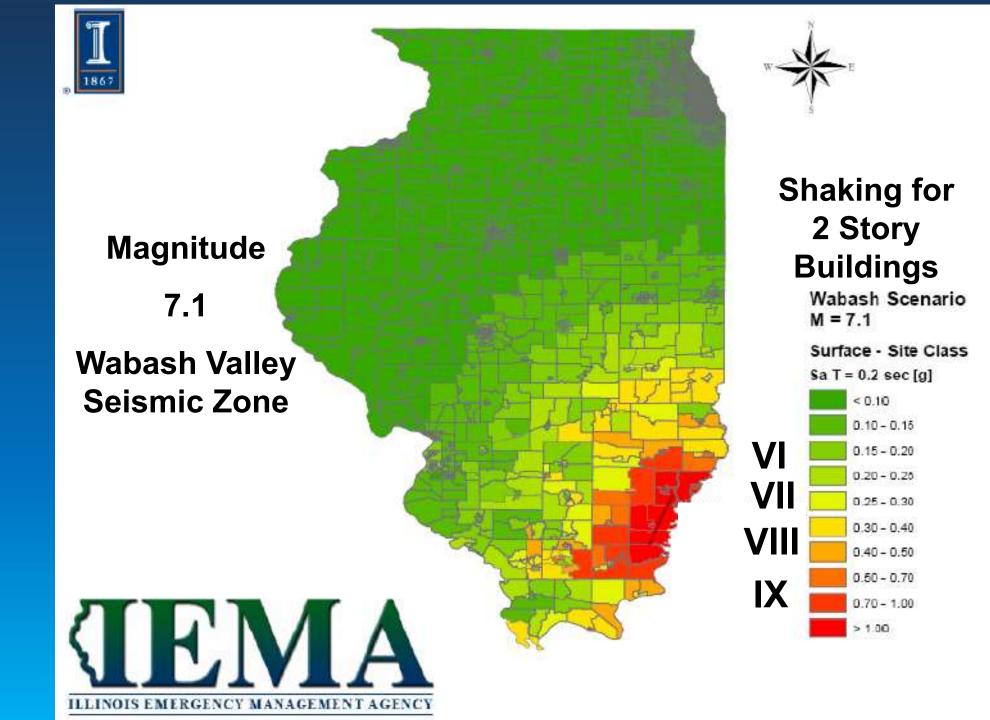
Mag. 7.1 in Wabash Valley

Estimated damage in Illinois

<u>Slight damage = 40,000</u> structures - small cracks in masonry chimneys and masonry veneer

<u>Moderate</u> = 19,000 - large cracks in chimneys toppling of tall masonry chimneys

Extensive = 4,000 - toppling of most brick chimneys, permanent lateral movement of floors & roof, cracks in foundations, partial collapse of soft story floors.

<u>Complete</u> = 6,500 - may collapse or be in imminent danger of collapse

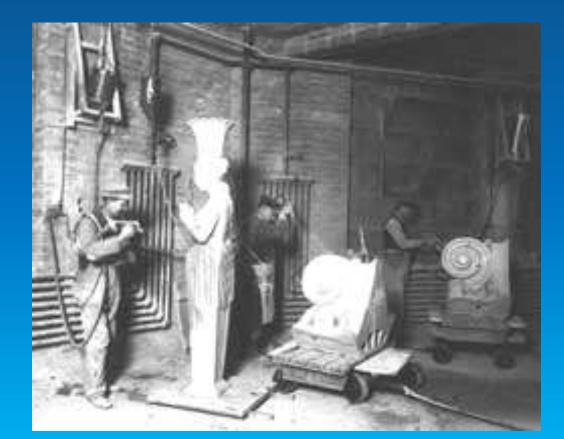
Terra Cotta pieces for building exteriors - Chicago
